# **Investigation of the Causes of Leaks in Natural Gas Pipeline Compression Couplings**

**Washington Gas Company**

**ENVIRON International Corporation**

July 1, 2005

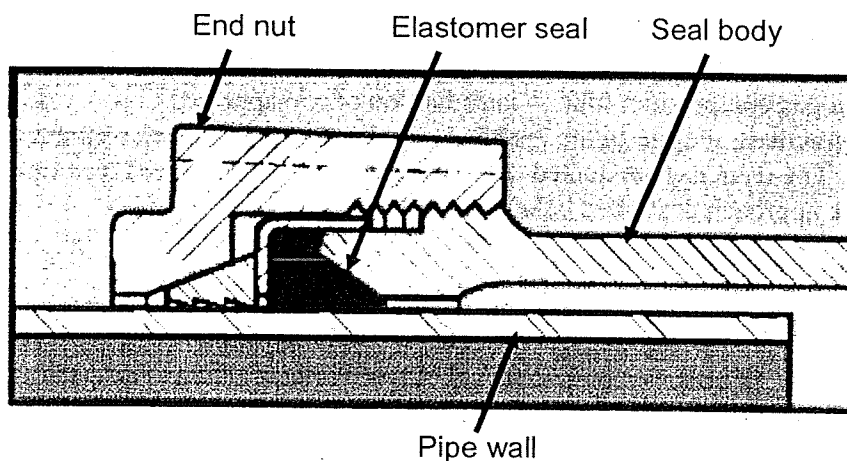
**Figure 2** Cross-section of Dresser coupling, showing location of elastomer seal.

In the last two heating seasons, Washington Gas (WG) experienced an unusually high number of leaks in particular areas of their distribution network. The couplings affected include 2 inch and ¾ inch Dresser Style 90 couplings with styrene butadiene rubber (SBR) elastomer seals and 2 inch and ¾ inch Normac couplings with nitrile butadiene rubber (NBR) elastomer seals. These couplings were installed between approximately 1958 and 1974. For reference, Figure 1 shows a 2" Normac coupling after removal from the ground. Figure 2 shows a cross section of a Dresser coupling, illustrating the location and configuration of the elastomer seal (the Normac couplings are very similar in arrangement). Figure 3 shows a seal from a 2" Normac coupling.
